INHIBITING CORROSION IN TRANSPORT PIPELINES BY VpCI ADDITIVES TO CRUDE OIL

Sanja MARTINEZ¹, Boris MIKŠIĆ², Ivan ROGAN³, Antonio IVANKOVIĆ¹

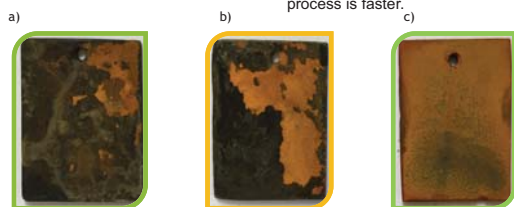
Appearance of the rust layer after 30 days of exposure to: a) inhibitor free solution, b) 60 ppm of VCI 629 BIO in 3.5% NaCl and c) 2000 ppm of VCI 629 BIO in 3.5% NaCl. Black layer presents magnetite and brown-orange lepidocrocite.

In the inhibitor free solution, magnetite band is more pronounced than the lepidocrocite band. This has also been confirmed visually, due to the specific colour of the compounds. Magnetite formation is known to be favoured in more aggressive environments where the oxidation process is faster.

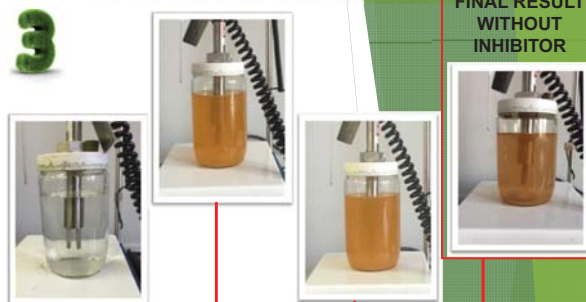
Corrosion rates in batch inhibitor application simulation, measured on LPR probe in stirred 3.5% NaCl, with stirring rod rate equal to 600 RPM.
